# **HORIZON INSPECTION SERVICE, INC.**

February 1, 2007

RE: 123 Bird Lane  
Sanibel, FL 33957

## **REPORT SUMMARY**

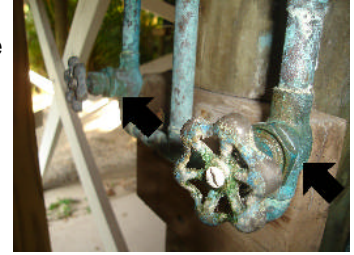
Exterior hose bibs are in good overall condition. Exterior shower is in fair overall condition. Leakage is noted a shutoff valves when the valves are opened.

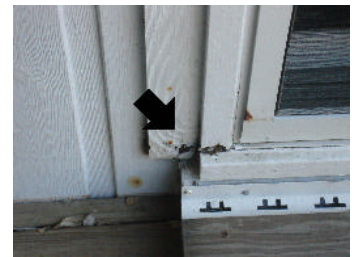
**Main Rear Entry:** Single. Wood. Good. Sliding glass. Good. Wood rot is noted at the lower right corner of the sliding glass door opening.

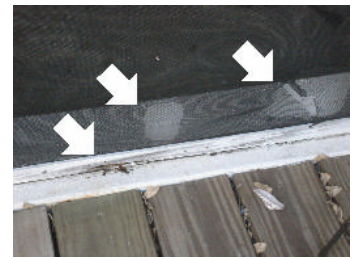
REAR SCREENED PORCH: Good overall condition. Wood rot is noted within the rear edge of the plywood subflooring near center (as viewed from below). A few damaged screen panels are noted and some minor rot is noted in lower horizontal trim at the left forward screen panel. Railing is loose near the right rear corner and some rot is noted down low.

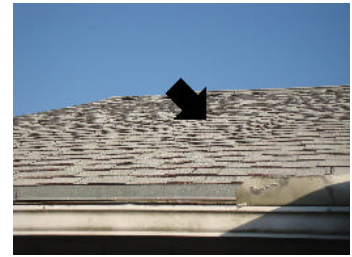
Good. Shingles appear to be recent replacements which have normal weathering commensurate with their estimated age. A small depression is noted at the left slope over the screened porch. Condition appears cosmetic and may simply be due to warped plywood decking. The area was walked upon with no adverse affect. Asphalt of Fiberglass roofing shingles generally have service lives of 10-12 years and 12-15 years respectively in this area of the country. Heavy duty shingles will often last 15-18 years before replacement is needed. Early signs of aging include brittleness, minor curling and a loss of mineral granules, while signs of advanced aging are severe curling, broken or split shingles and exposed felts. The useful life of a roof can be extended by patching and coating eroded or worn areas as they become evident. As a roof approaches the end of its economic life expectancy, patching increasingly becomes necessary, due to an increased likelihood of leakage in the last few years of roof life.

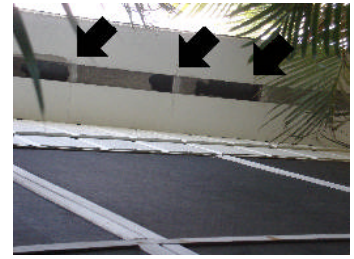
A combination of soffit and ridge vents. Soffit vent screens are damaged.

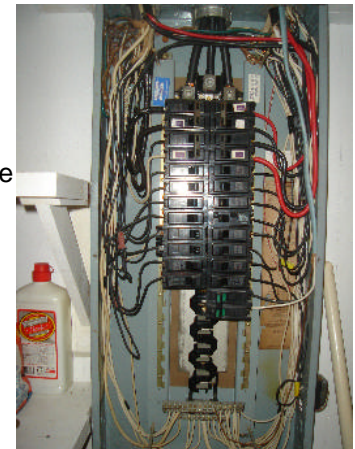
Good overall. Multistranded aluminum branch wiring is installed without antioxidant paste. Good electrical practice dictates that stranded aluminum wiring be installed with the use of anti-oxidant paste, applied to the exposed ends of wiring and provided to prevent the formation of non-conductive aluminum oxide. While no signs of overheating or problems are evident at this point in time, you should request your electrician apply some to the above mentioned wires the next time he is called out for other work.

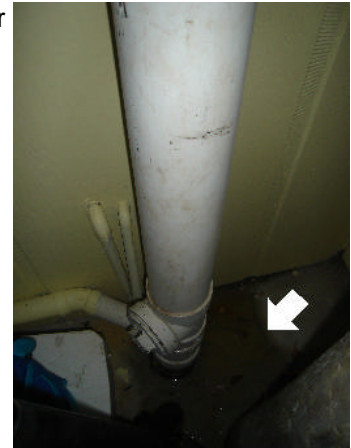
Active leakage is noted at the main drain line under the house.

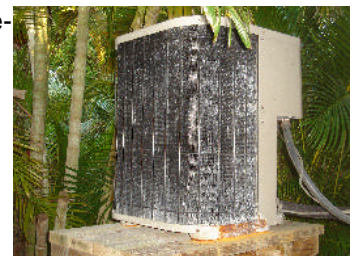
**Condenser:** Goodman Manufacturing brand. Manufacture Date-1997.

**Condition:** Unit has heavy rust at the bottom and is in fair condition. Unit has a limited anticipated life remaining. Condenser cabinets of this type typically have a service life of 10-15 years. As a condenser cabinet nears 10 years of age, it has an increased likelihood of breakdown in the future. Air conditioner sizing is proper when 1 ton of air conditioning is provided for each 500-600 square feet of living area. Allowances should be made for ceiling insulation in excess of R-19.

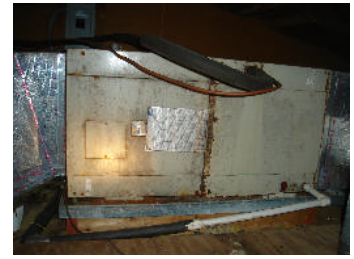
**Air Handler:** Carrier brand. Manufacture Date- 1985.

**Condition:** Unit is heavily rusted and in fair overall condition. Unit has a limited anticipated remaining service life. Most evaporators of this type have a service life of 10-15 years. Any evaporator nearing 10 years of age has an increased likelihood of breakdown in the future. Evaporator cabinet is horizontally mounted unit installed within the attic and is appropriately sized in relation to its exterior condenser unit. Blower fan pulls proper amperage and no operational problems were noted at the time of the inspection.

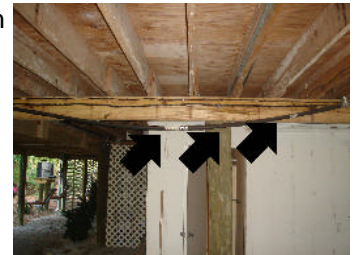
**Condensate Stains:** No significant staining was seen. Condensate drain line is not properly secured where installed below the house.

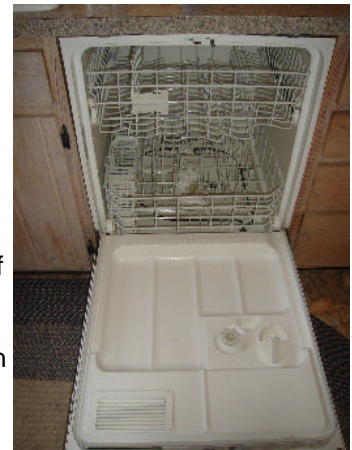
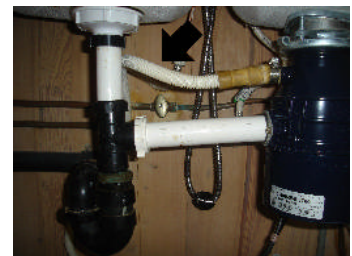
**CONDITION:** Good. Most dishwashers have expected service lives of 8-12 years. A proper air gap IS NOT installed in the dishwasher drain line. An air gap is required in the drain hose running from the dishwasher to the main drain under the sink. Air gaps assist in positive drainage and act to prevent clogging, as well as serving to prevent back siphoning in the event the sink becomes clogged. This line, located under the sink, is usually made of rubber or copper. The easiest way to create an air gap is to raise the drain hose at some point along its route so it passes 6 inches ABOVE the elevation at which it empties into the main drain. Wire or some other means of support can easily be installed to insure the hose stays in place. A licensed plumber can make this repair in a few minutes.
