**Report:** 0223410 **Address:** 12732 Hackberry Lane

**Confidential Inspection Report**  
**12732 Hackberry Lane**  
**Fort Myers, FL 33908**

**Prepared for: Mr & Mrs John & Kathleen Greene**

July 14, 2014

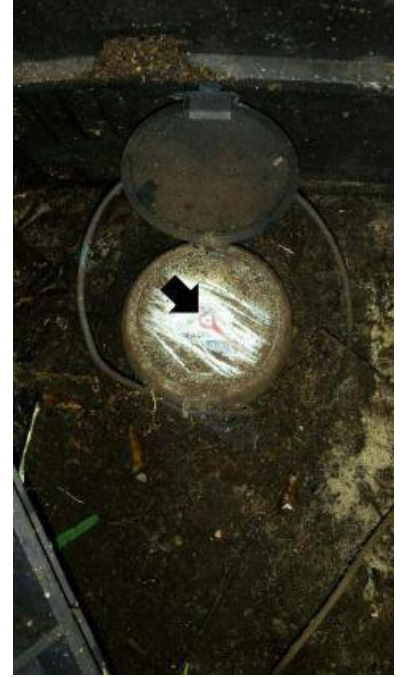
City. Water usage is occurring when all plumbing fixtures are closed, as evidenced by movement of the flow indicator on the water meter.

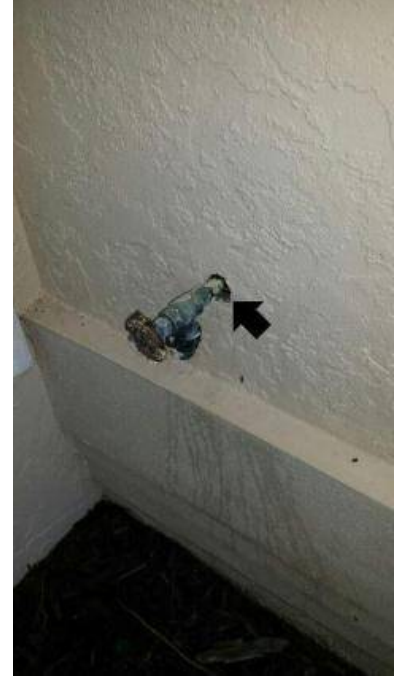
Exterior hose bibs are in good overall condition. The potential for moisture intrusion to occur is present around the front hose bib. Seal opening.

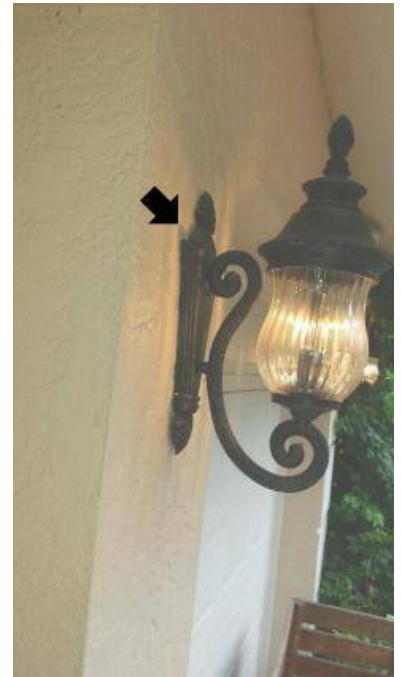
The potential for water intrusion exists where the bases of wall mounted lights are not sealed. Bad bulbs are suspected where some lights failed to operate. Includes landscape lighting. GFI protection is provided at some exterior locations.

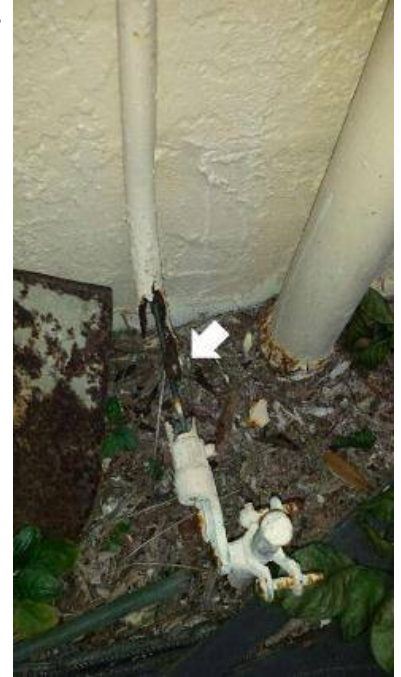
Conduit through which the ground wire passes (located below the electric meter) is rusted near the ground.

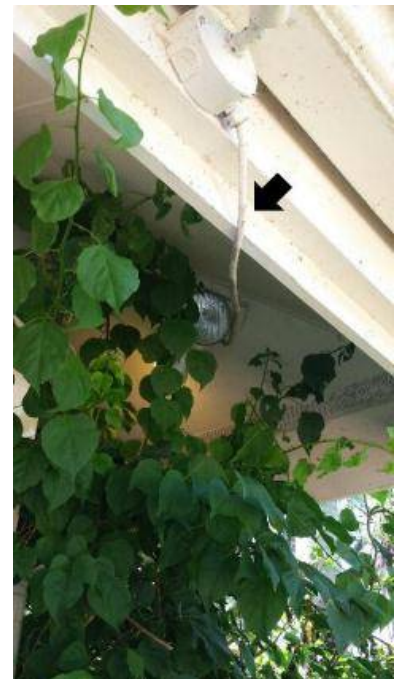
Good overall condition. Surface routed wires are noted at the garage spot lights. Outlets at the front entry and to the left of the front entry failed to respond to GFI testing.

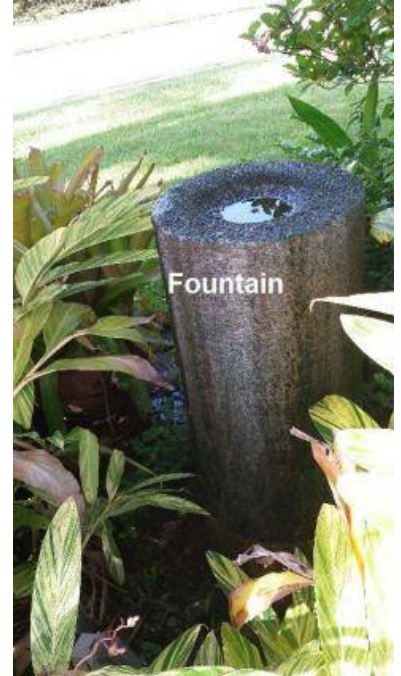
GFI outlet serving the front fountain failed to reset. Fountain is operating too long and making the plant bed very wet. Surface routed wiring is noted at the front wall timers and terminal protectors are not installed at the timers. Inquire with seller to determine what the timers serve.

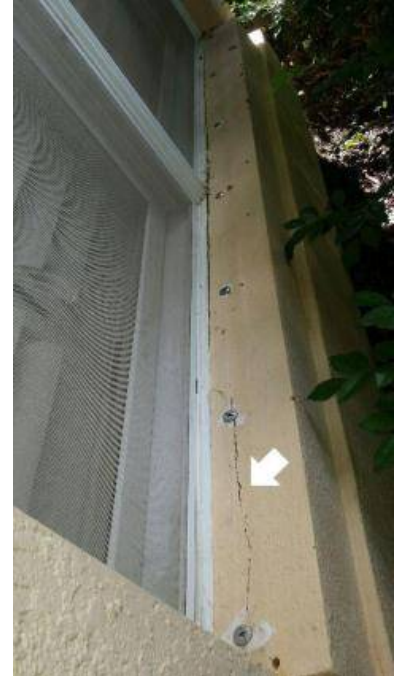
Good. Some of the window screens are not installed. Some of the lower blocks are cracked at the glass block window.

*Sill Type and Condition:* Masonry. Good overall. The right front bedroom window sill is cracked.

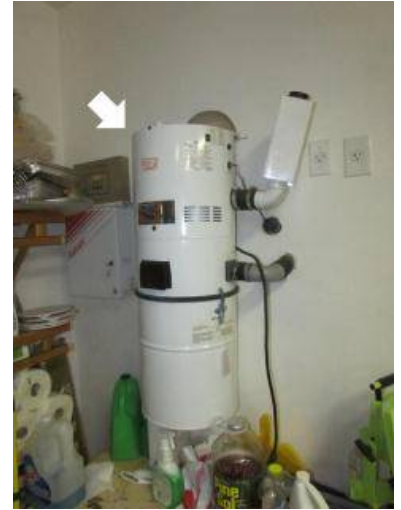
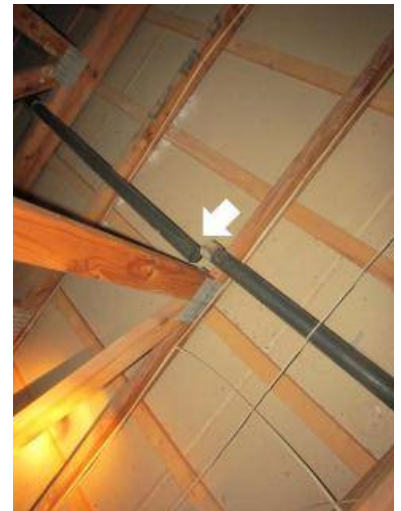
*Central Vacuum System:* System was unplugged on arrival. The main collection cannister responded once plugged in. Individual suction ports were not tested. One of the vacuum lines is disconnected over the garage.

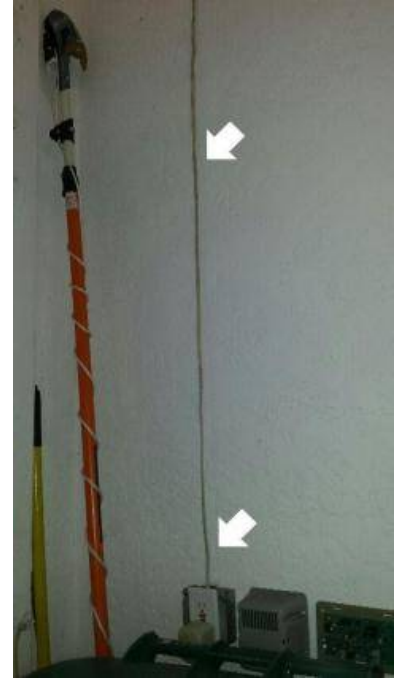
One light cover is not installed. Surface routed wiring is noted at the left front corner.

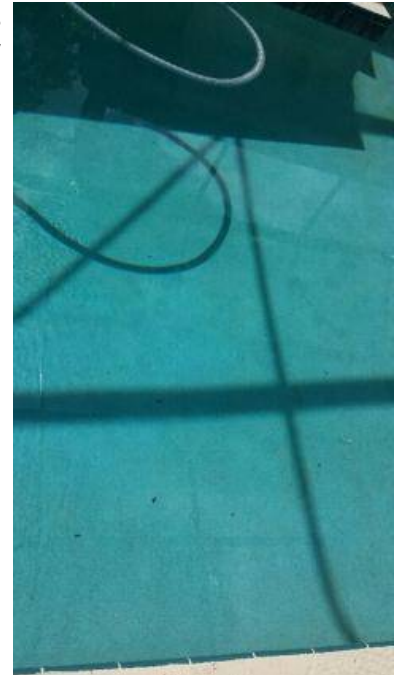
Fair overall condition with surface wear, cracks and deterioration. A licensed pool contractor should be called to provide further evaluation and cost for repairs/resurfacing.

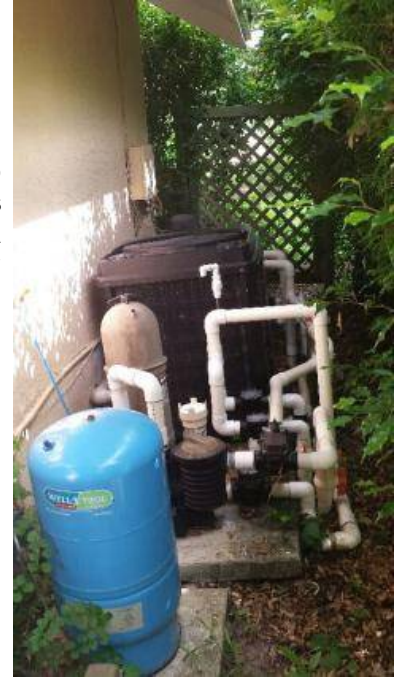
Fair overall. The pool equipment cement pad has settled. Equipment is not level. Three 2.0 hp pumps are provided in fair overall condition. A bond wire is not secured to two of the pump, electrical wire is not secured to the rear pump and the rock fall pump failed to operate. In addition, a loss of prime occurs when the swim jet pump is activated. A licensed pool contractor should be called for further evaluation.

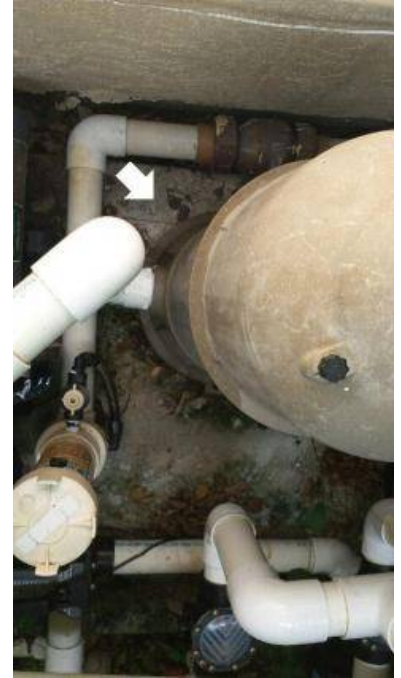
Leakage is noted at the pump and filter.

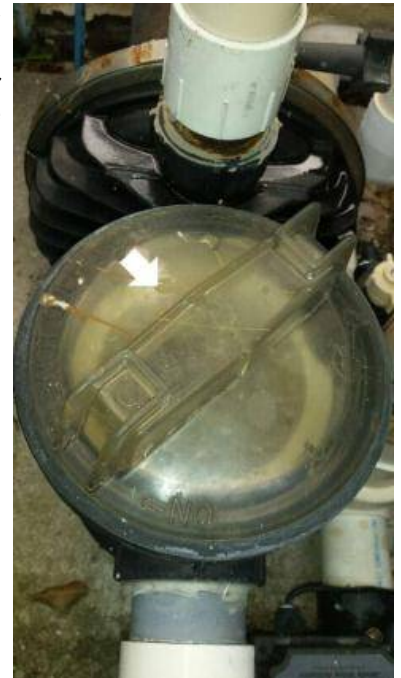
Air bubbles were seen passing through the hair and lint filter on the pumps and exiting the pool supply jets. This is an indication of a minor leak somewhere along the suction side of the pumping system, which is likely occurring relatively close to the pump, at a valve, chlorinator fitting or at the O-ring under the hair and lint filter cover, but could also originate underground at a small pipe break.

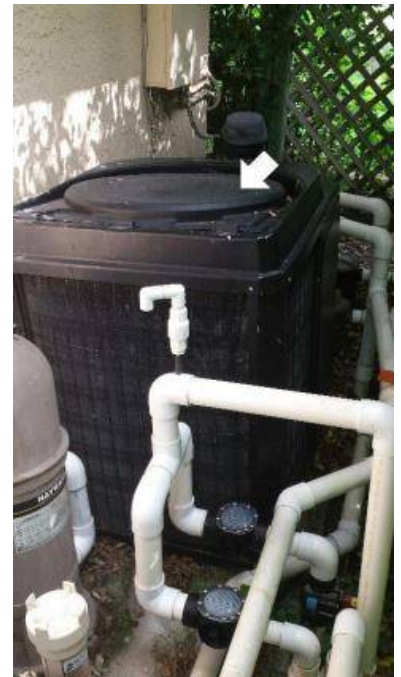
Good visual, but heater failed to respond to use of controls.

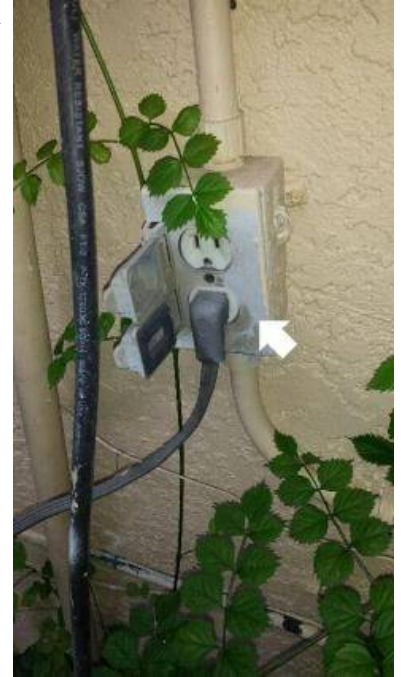
Good. Outlet serving the timer is without a weatherproof cover.

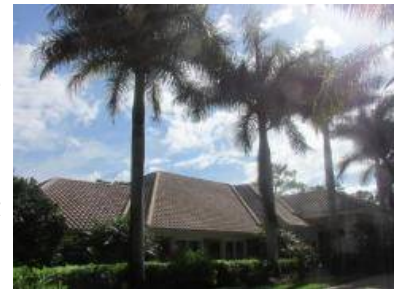
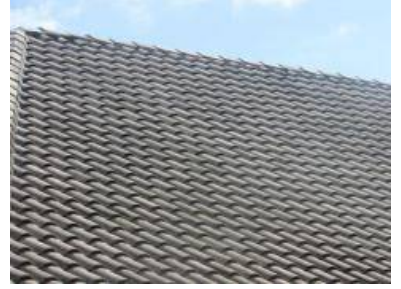
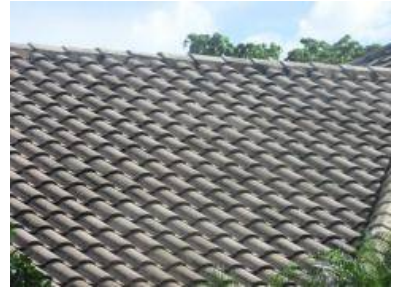
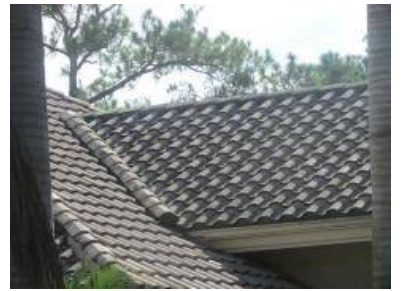
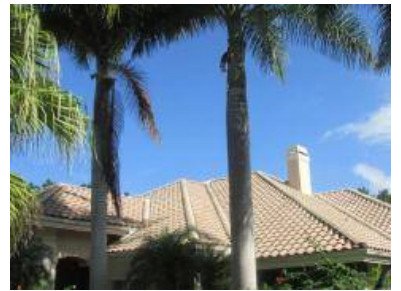
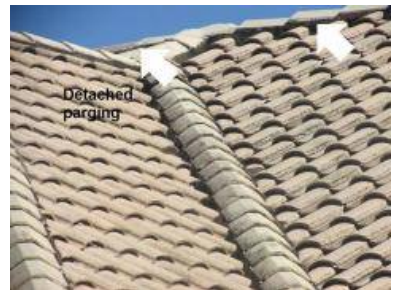
*Overall Condition:* While roof tile are generally in good condition a few cracked/damaged tile are noted. In addition, parging is detached at some of the ridge and hip tile leaving tile loose in place and subject to wind uplift. Evidence of prior repairs are noted in at a few locations. Inquire with seller to determine history. As noted at overhangs and attic there are areas of wood rot and evidence of roof edge leakage. This roof is at a point in its life where leakage, repairs and replacement should be anticipated. A licensed roofing contractor should be called for further evaluation and to provide costs for repairs/replacement. In addition, the small flat roof should also be evaluated.

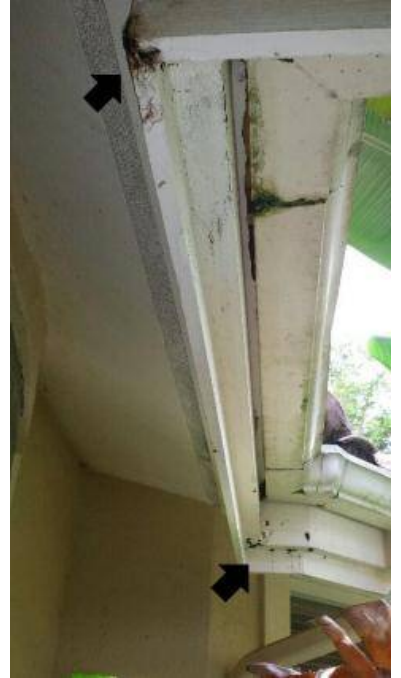
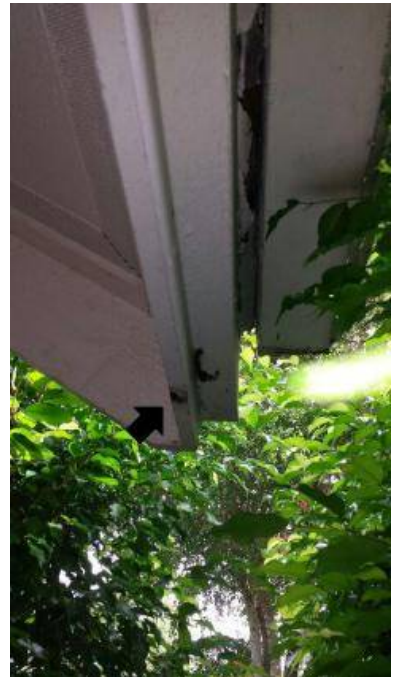
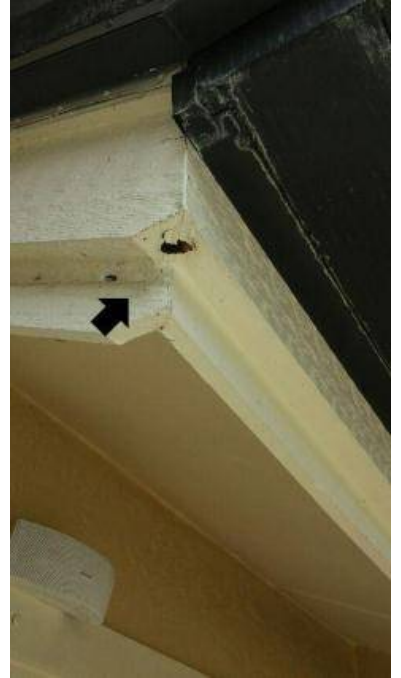
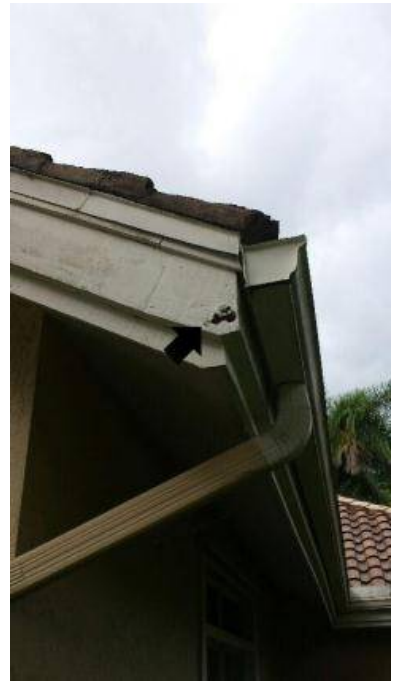
of fascia. A licensed roofing contractor should be called for further evaluation and to provide repair vs replacement costs.

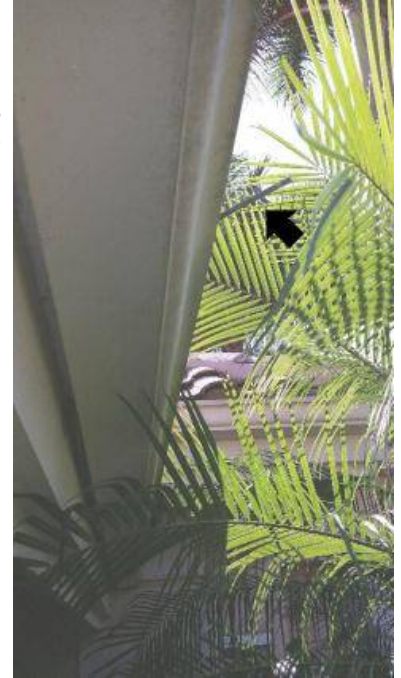
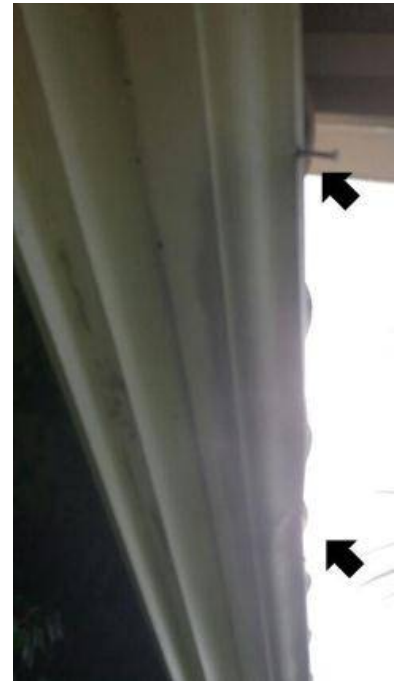
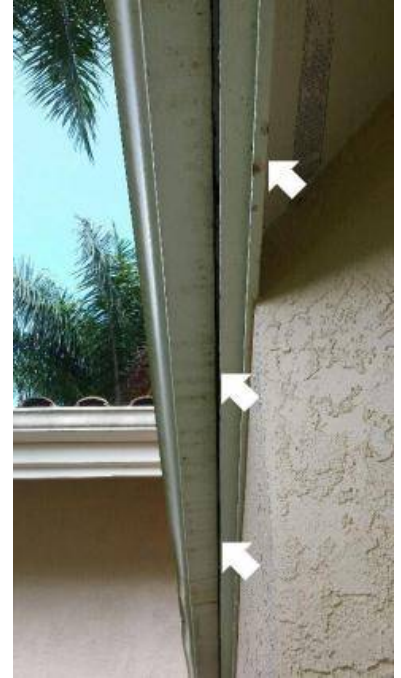
Fair overall condition. Some gutter joints have or are leaking. Use gutter caulk to seal. Loose nails are noted along with some dented sections of gutter. Stains indicate leakage is occurring between the front gutters and the overhang.

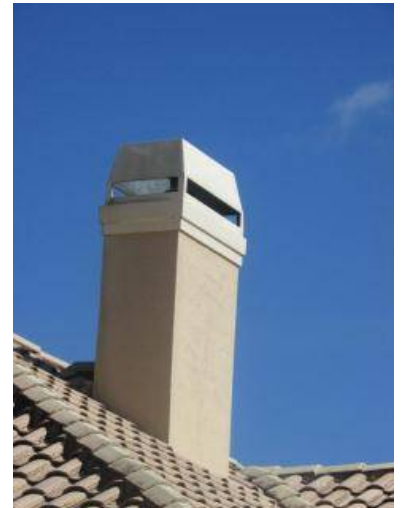
Two are provided in good overall condition with some rot noted in wood trim.

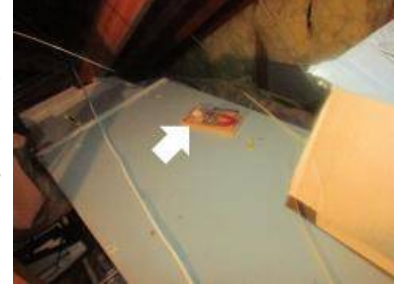
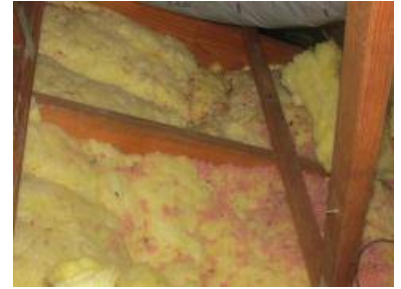
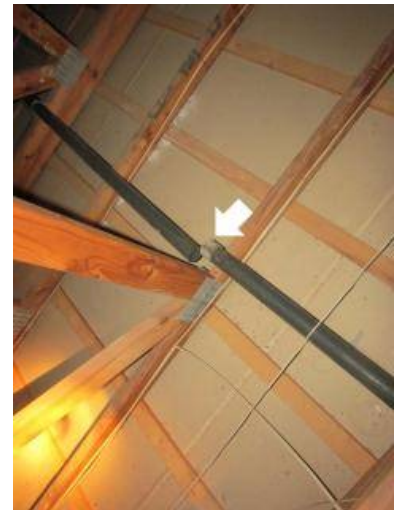
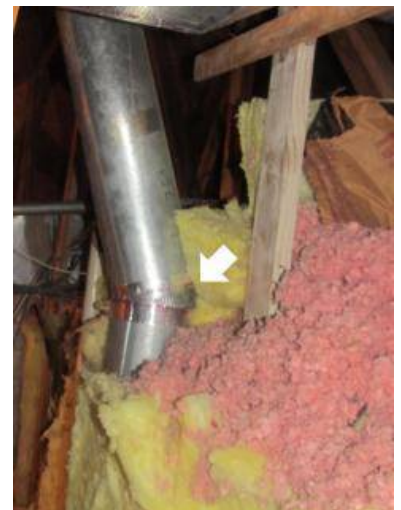
Evidence (droppings, traps and insulation trails) of rodents was noted. A few exposed electrical junctions are noted. One piece of the central vacuum system pipe is disconnected over the garage. Switch cover is damaged at the garage attic light. The dryer vent duct is partially detached.

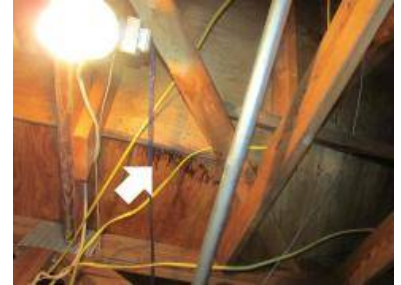
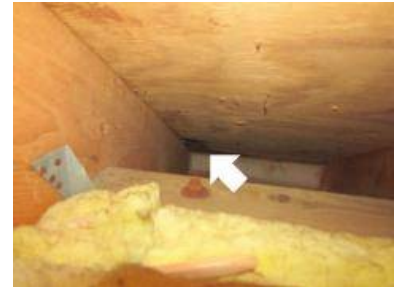
Stains and rot are noted at some overhangs and at the raised front entry. Dry stains are present just above the garage attic access.

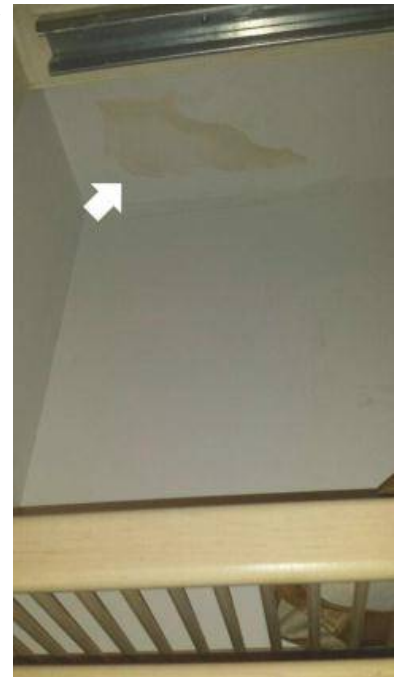
*Den Bath:* Dry ceiling stains are noted. Inquire with seller to determine history.

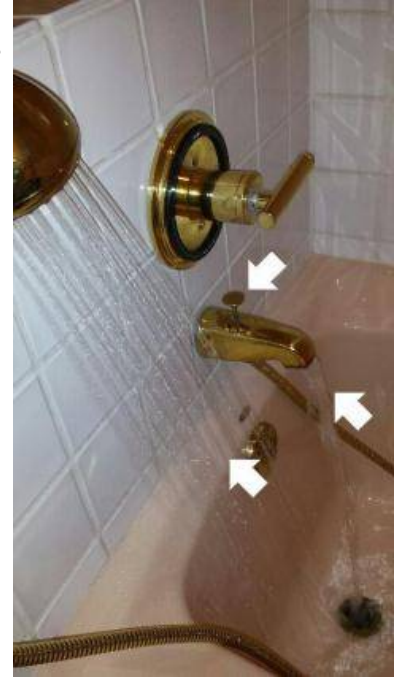
*Tub/Shower Fixtures:* Good overall. The shower diverter failed to fully engage and the pop up stopper is inoperative.

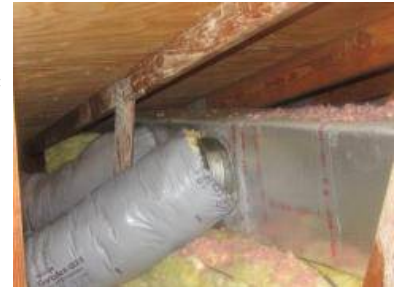
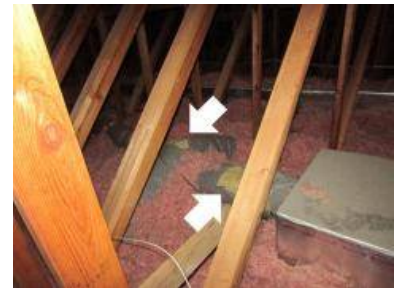
Most filters are in poor condition and in need of replacement. The plastic outer covering has deteriorated on some flexible ducts in the attic area. This is believed due to UV exposure and is typical for this type of duct, but is generally a progressive condition that eventually requires replacement.

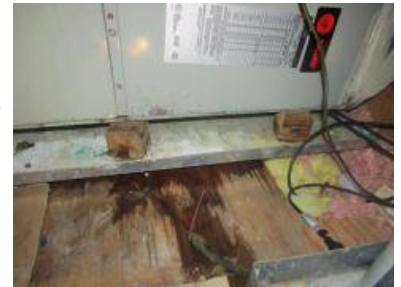
Fair. Unit is older and has a limited anticipated remaining service life. Most evaporators of this type have an expected service life of 10-15 years. Any evaporator nearing 10 years has an increase likelihood of the need for repairs in the future. Evaporator unit is a horizontally mounted unit installed within the attic area, and is appropriately sized to it exterior condenser unit. Evaporator unit in the attic area has a problem which will require further evaluation, along with repair and/or replacement by a licensed air conditioning contractor. The evaporator cabinet, which contains a collection pan for all condensation which forms within the unit, is leaking condensate water into the emergency overflow pan, which is located below the unit. The source of the leak should be found and repaired. The likelihood for repair is higher when no significant rust is found at the bottom surface of the evaporator cabinet. Excessive rusting generally requires the unit be replaced, a major expense. The emergency overflow pan is provided to keep ceilings from being ruined in the event of just such a leak as you have, and not meant to serve continuous duty.

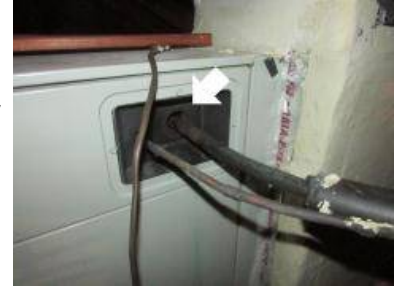
Minor hot infiltration is occurring at the evaporator in the following area(s): Where refrigerant and/or condensate lines enter the unit. A licensed air conditioning contractor should be called to seal areas of leakage as leakage can affect operation and service life.

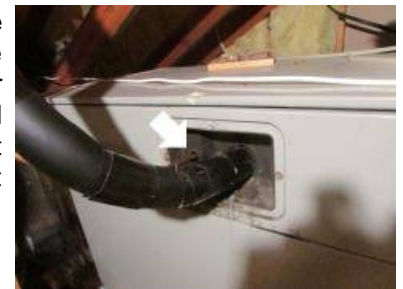
Major cold air leakage is occurring at the evaporator in the following area(s): At service cover panel seams. A licensed air conditioning contractor should be called to seal areas of leakage as leakage can affect operation and service life. Where refrigerant and/or condensate lines enter the unit.

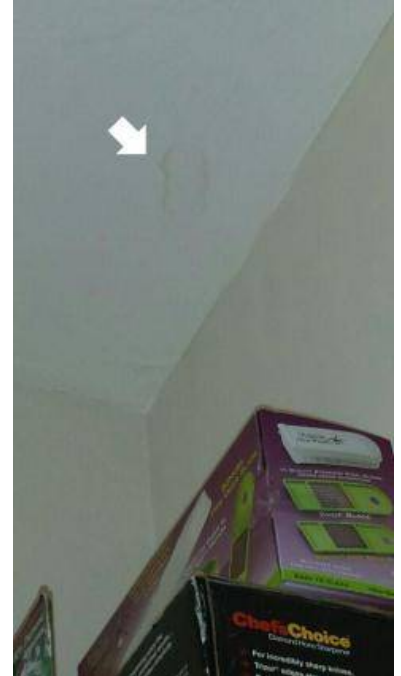
Dry stains are noted in the pantry closet. Inquire with seller to determine history.

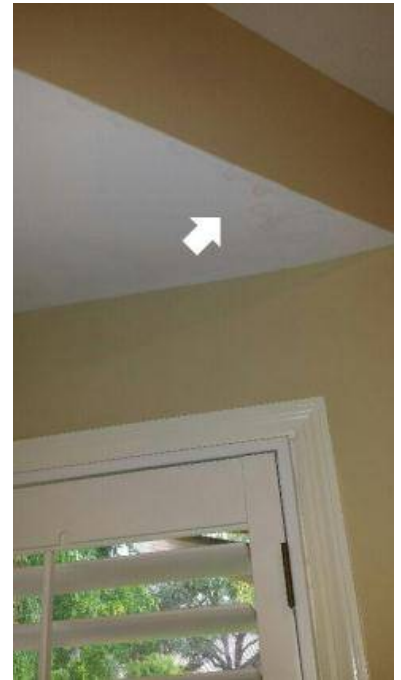
Dry stains are noted over the windows. Inquire with seller to determine history.
