**Report:** 0223410 **Address:** 12732 Hackberry Lane

**Confidential Inspection Report**  
**12732 Hackberry Lane**  
**Fort Myers, FL 33908**

**Prepared for: Mr & Mrs John & Kathleen Greene**

July 14, 2014

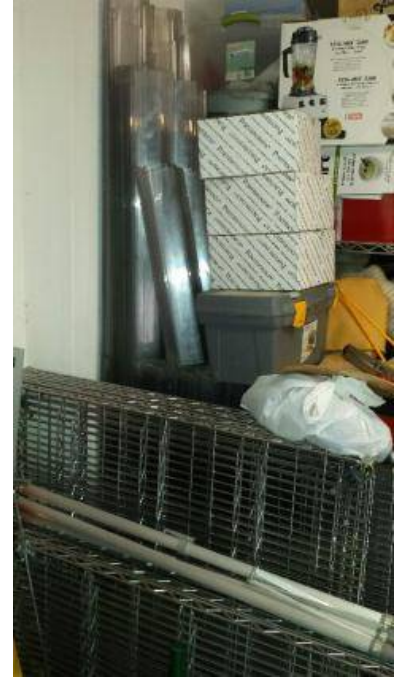
*SHUTTERS:*

Hardware for the installation of hurricane protection is installed. Panels are stored on site and appear in good condition.

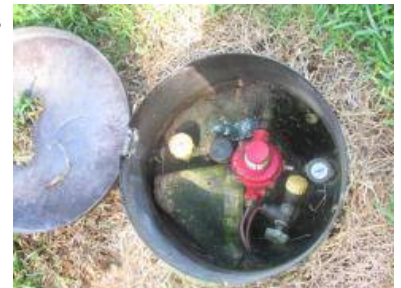
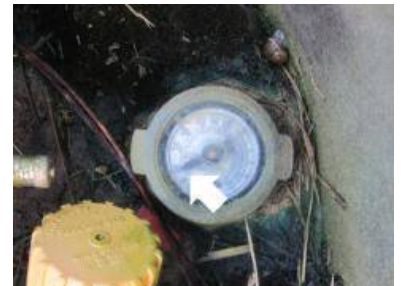
*OTHER:*

LP Gas Tank: Buried. Gas indicates the tank is 10% full.

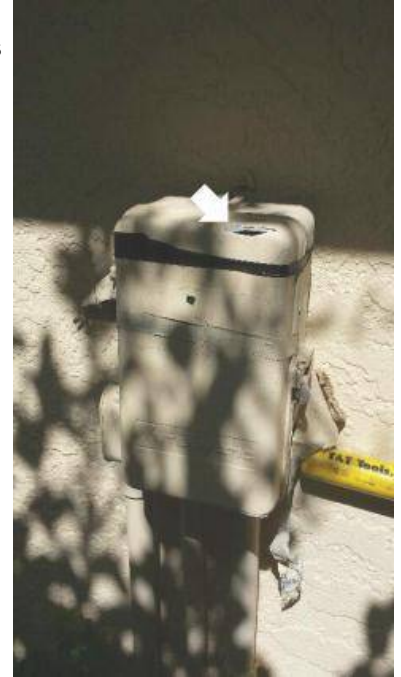
### *Subpanels:*

A timer has been removed from the enclosure. Timer box has been taped closed, has exposed splices inside and a hole in the enclosure.

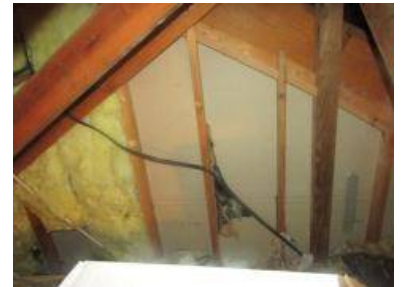
*Insulation Type (estimated R-Value):*

12 inches of blown Fiberglass: R-30. Some insulation has been disturbed.

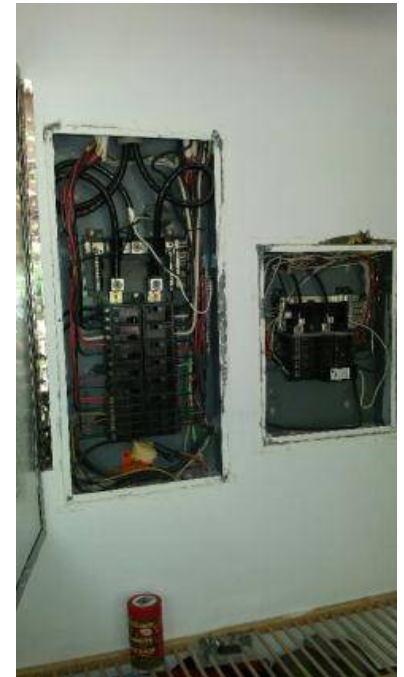
*INCOMING MAIN CABLES:* 4/0 aluminum. Main entrance cables are adequately sized for installed service. Antioxidant paste has been applied.

*BRANCH PANEL LOCATIONS:* Garage and master bedroom.

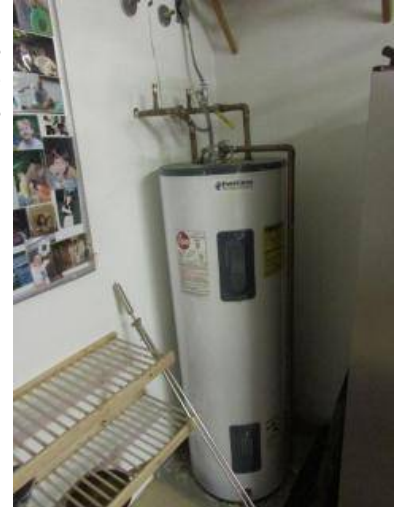
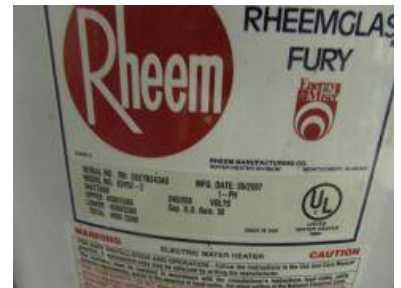
**CONDITION:**

Fair. Most water heaters have expected service lives of 10-15 years. Water heaters served by well water or ones which are installed at exterior locations may not last as long.

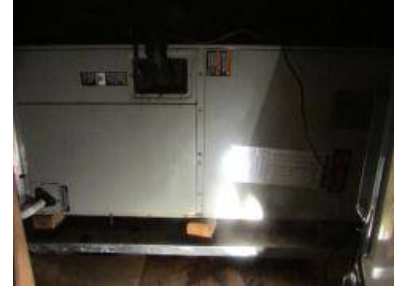
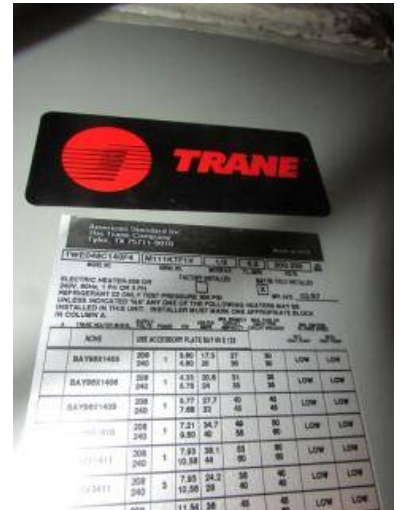
**AIR HANDLER:**

Trane brand. Manufacture Date: 1997.

Fair. Unit is older and has a limited anticipated remaining service life. Most evaporators of this type have an expected service life of 10-15 years. Any evaporator nearing 10 years has an increase likelihood of the need for repairs in the future. Evaporator unit is a horizontally mounted unit installed within the attic area, and is appropriately sized to it exterior condenser unit. Evaporator unit in the attic area has a problem which will require further evaluation, along with repair and/or replacement by a licensed air conditioning contractor. The evaporator cabinet, which contains a collection pan for all condensation which forms within the unit, is leaking condensate water into the emergency overflow pan, which is located below the unit. The source of the leak should be found and repaired. The likelihood for repair is higher when no significant rust is found at the bottom surface of the evaporator cabinet. Excessive rusting generally requires the unit be replaced, a major expense. The emergency overflow pan is provided to keep ceilings from being ruined in the event of just such a leak as you have, and not meant to serve continuous duty.

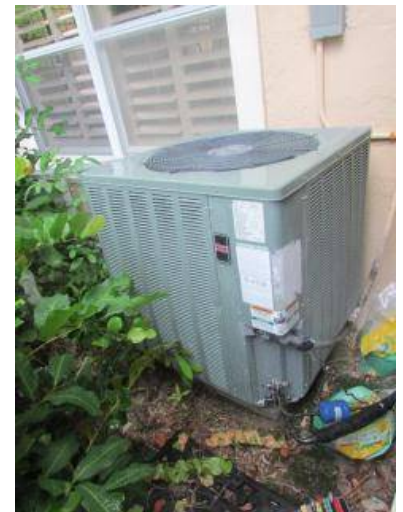
*CONDENSER:* Ruud brand. Manufacture Date: 2011.

Minor hot infiltration is occurring at the evaporator in the following area(s): Where refrigerant and/or condensate lines enter the unit. A licensed air conditioning contractor should be called to seal areas of leakage as leakage can affect operation and service life.

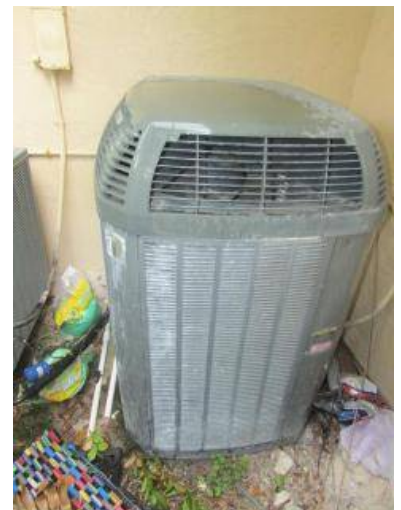
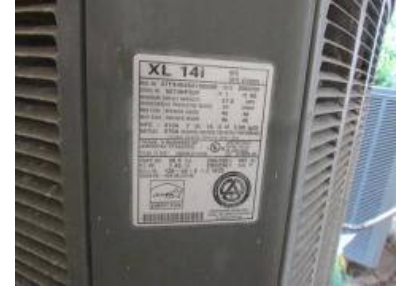
**CONDENSER:**

Trane brand. Manufacture Date: 2005.

Fair. Condenser cabinets of this type typically have a service life of 10-15 years. As a condenser cabinet nears 10 years of age, it has an increased likelihood of the need for repairs in the future. Air conditioning sizing is proper when 1 ton of air conditioning is provided for each 500-600 square feet of living space. Other considerations are ceiling height and insulation.

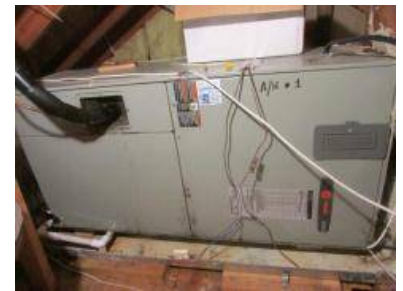
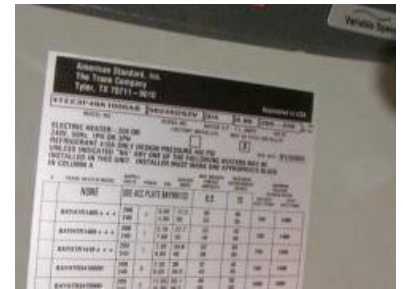
**AIR HANDLER:**

Trane brand. Manufacture Date: 2005.

Fair. Most evaporators of this type have an expected service life of 10-15 years. Any evaporator nearing 10 years has an increase likelihood of the need for repairs in the future. Evaporator unit is a horizontally mounted unit installed within the attic area, and is appropriately sized to it exterior condenser unit. Blower fan pulls proper amperage and no operational problems were noted at the time of the inspection.
